# Collapse of the World Trade Center Towers

Written by G Charles Clifton,  
HERA Structural Engineer

17<sup>th</sup> September 2001 and revised 19<sup>th</sup> September.

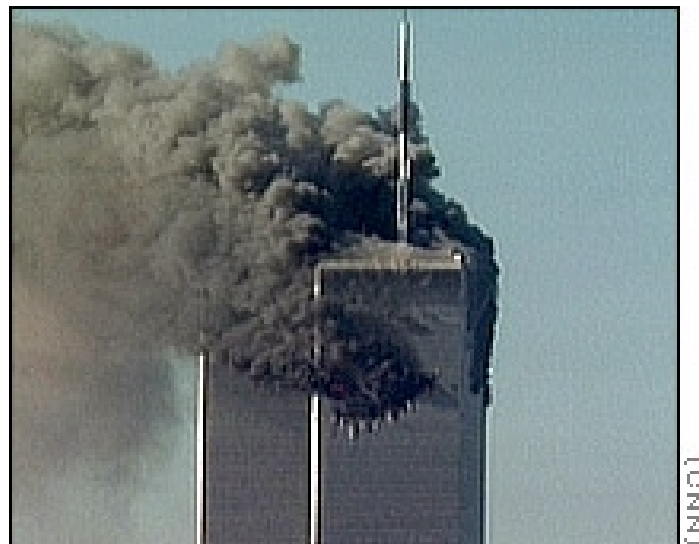
Fig. 9  
North Tower After Impact Viewed From the Impact Side  
(Photo from CNN)

Fig 9 shows the view looking into the impact hole. Given that the floor slabs are at 3.66 m centers and the façade column centers are at 1.03 metre centers with façade window widths of only 0.48 m, the number of façade columns and perimeter beams severed by the airplane in its passage through the perimeter frame is considerable. From the major damage to the side opposite the impact it is also apparent that much of the airplane would have passed through the core. It is likely that the impact destroyed most of the floors, at least on the impact side, and the core on at least three levels, removing many of the core supporting columns, at least on the North side of the core, and leaving the remainder buckled and stripped of their passive fire protection. This would have caused the floors above the impact level to sag

downwards in the center, with the gravity columns above the impact region now acting as tension ties between each of the upper floors, through to the top floor. Each upper floor would now have had to be at least partially supported off the perimeter frame. HERA has developed a method (based on UK fire research) allowing the design of unprotected secondary beams in composite floor systems by using the dependable inelastic reserve of strength from a region of floor slab supported around its perimeter. I have applied this in a very approximate manner to a typical WTC floor slab supported off only the perimeter frame and the result shows that this is just about possible with regard to the membrane capacity of the floor system, but not possible in terms of the vertical load carrying capacity of the connection between the floors and the perimeter frame. As the vertical load carrying capacity of the core diminished, requiring more load to be transferred from the floors to the perimeter frames, the mode of failure would have most likely been failure of this connection, leading to floor collapse.

1. If the temperatures inside large regions of the building were in the order of 700+ deg C, then these regions would have been glowing red hot and there would have been visible signs of this from the outside. Also there would have been visible signs of flames. If one looks at the photos of the Cardington fire tests, the flames and glowing of the steelwork is clearly visible even in the large enclosure test where the maximum fire temperature was only 700 Deg C. In contrast, the pictures of the towers after the collapse and prior to the impact show sign of severe burning over only relatively small regions of the tops of the towers, even pictures taken from the air looking horizontally into the impact region (eg Fig.9).

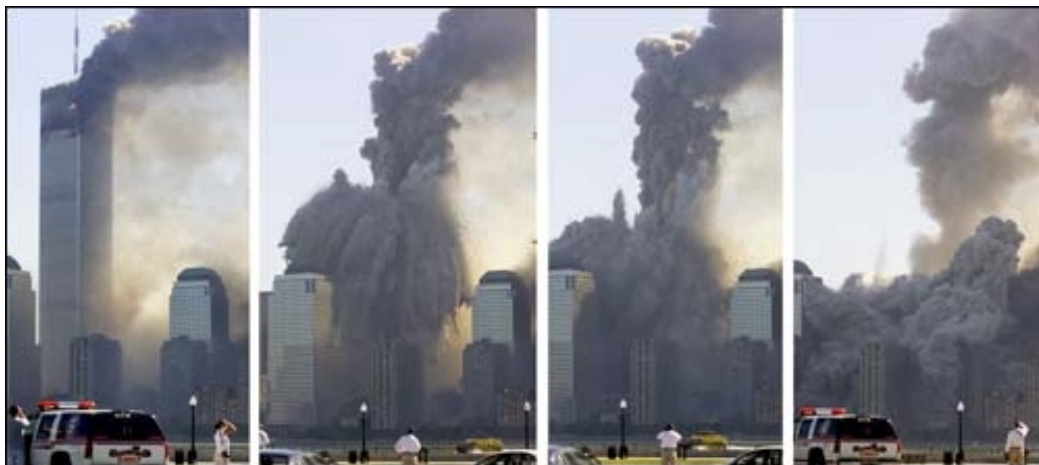
Fig. 10  
Sequence of Collapse of North Tower  
( Photo from CNN)

The collapse then continued down the building, with the floors pancaking leaving the perimeter frames briefly standing unsupported until they too collapsed. The effect of the floors pancaking nearly straight down inside the perimeter frames lead to the North tower effectively imploding, with some sections of the perimeter frame remaining standing unsupported for a few seconds before collapsing. This is seen from a number of video footages and pictures, including the collapse sequence shown in Fig 10.

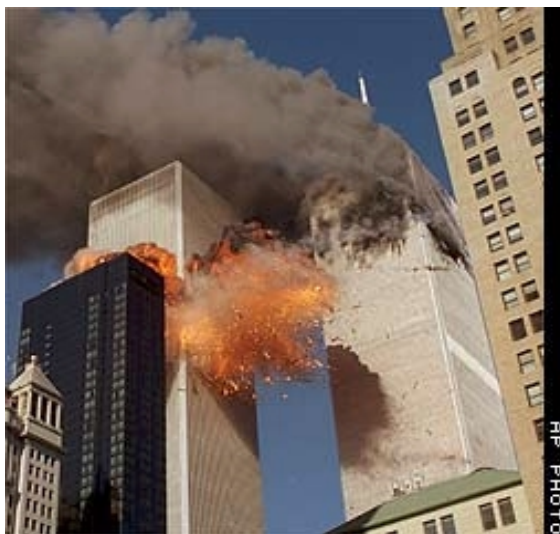
Fig.11  
Fireball From Impact on South Tower  
(Associated Press photo)

At 9.03 am the plane impacted the South side of the south tower towards the South East corner. It struck the building at an angle across that corner and on a slight downwards heading, as shown in Fig.2. The plane passed into the building and then exploded out of the adjacent East side, causing a large fireball to erupt from both the entry and exit sides adjacent to the South East corner. Fig. 8 shows the plane immediately before impact and Fig 11 shows the expanding fireball erupting from both sides of the building.

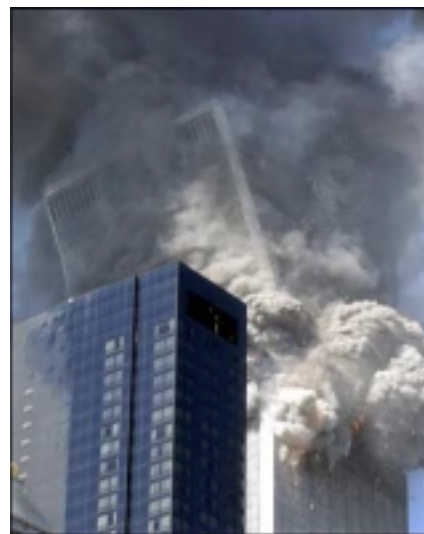
Fig.12  
Top of South Tower Collapsing  
(Photo from CNN)

Finally the combination of increasing compression load on these damaged columns, with second order effects from this load acting on the buckled shape of these columns over their unsupported length, would have caused their collapse. This collapse would have initiated in the damaged corner and spread rapidly over the impact region, causing the tower above to fail by toppling sideways with the floors above the impact region momentarily in an intact condition. This stage of the collapse is shown in Fig. 12.
