# Collapse of the World Trade Center Towers

Written by G Charles Clifton,  
HERA Structural Engineer

17<sup>th</sup> September 2001 and revised 19<sup>th</sup> September.

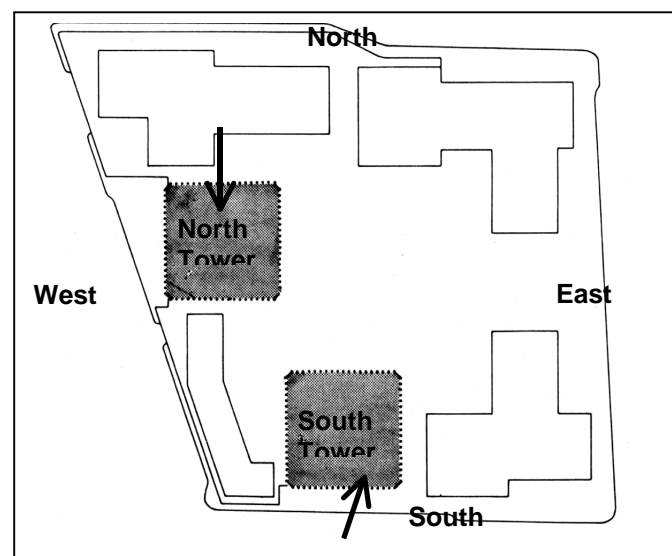
Fig. 2  
Site Plan of World Trade Center Development Showing Location of the  
Two Towers

(The direction of arrows adjacent to each tower shows the approximate direction of the planes on impact)

Each tower was hit by a Boeing 767. The impact on the North tower was near the center of the North face at around the 95<sup>th</sup> storey, with the plane hitting the side of the building square on and flying level. The impact on the South tower was some 15 storeys lower, with the plane hitting the South face near the South East corner and impacting at an angle to the face of the tower. Fig 2 shows the impact directions and Fig 8 shows the plane about to hit the South Tower.

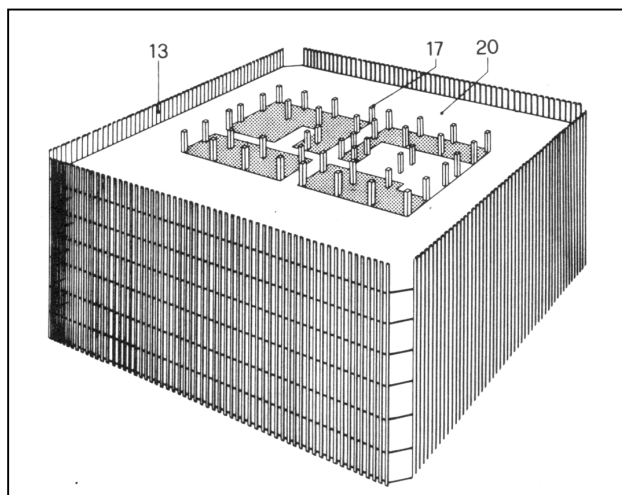
**Fig. 3**  
Isometric View of Building  
(from [1])

The numbers in the figure are taken from [1] and denote:  
13 – Perimeter frame  
17 – Core box columns 450 mm square  
20 – Floor slab

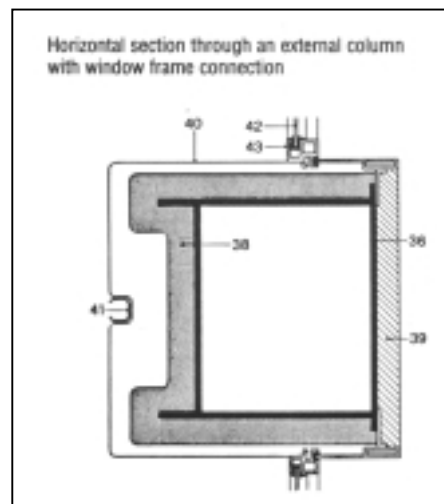
**Fig. 4**  
Cross Section Through  
Exterior Box Column (from [1])

The numbers in the figure are taken from [1] and denote:  
36 – Steel column  
38, 39 – Fire resistant plaster  
40 – Aluminium façade  
42 – Window glass  
43 – Window frame

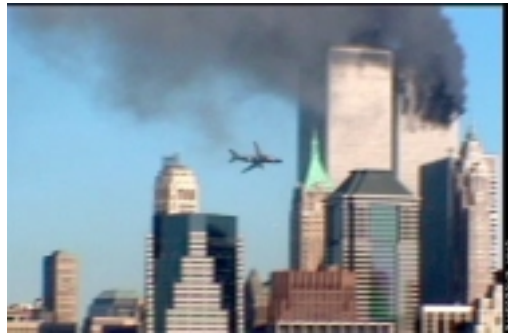
Fig. 8  
Plane About to Hit South Tower  
(Photo from CNN)

At 9.03 am the plane impacted the South side of the south tower towards the South East corner. It struck the building at an angle across that corner and on a slight downwards heading, as shown in Fig.2. The plane passed into the building and then exploded out of the adjacent East side, causing a large fireball to erupt from both the entry and exit sides adjacent to the South East corner. Fig. 8 shows the plane immediately before impact and Fig 11 shows the expanding fireball erupting from both sides of the building.
